**Subject: Final Expanded Site Inspection Report  
Latex Construction Company  
EPA Contract No. 68-W-00-120  
EPA ID No. GAD980803696  
Technical Direction Document No. 4T-01-10-A-006**

**FINAL EXPANDED SITE INSPECTION REPORT**  
**LATEX CONSTRUCTION COMPANY**  
**THUNDERBOLT, CHATHAM COUNTY, GEORGIA**  
**US EPA ID NO. GAD980803696**

**Revision 1**

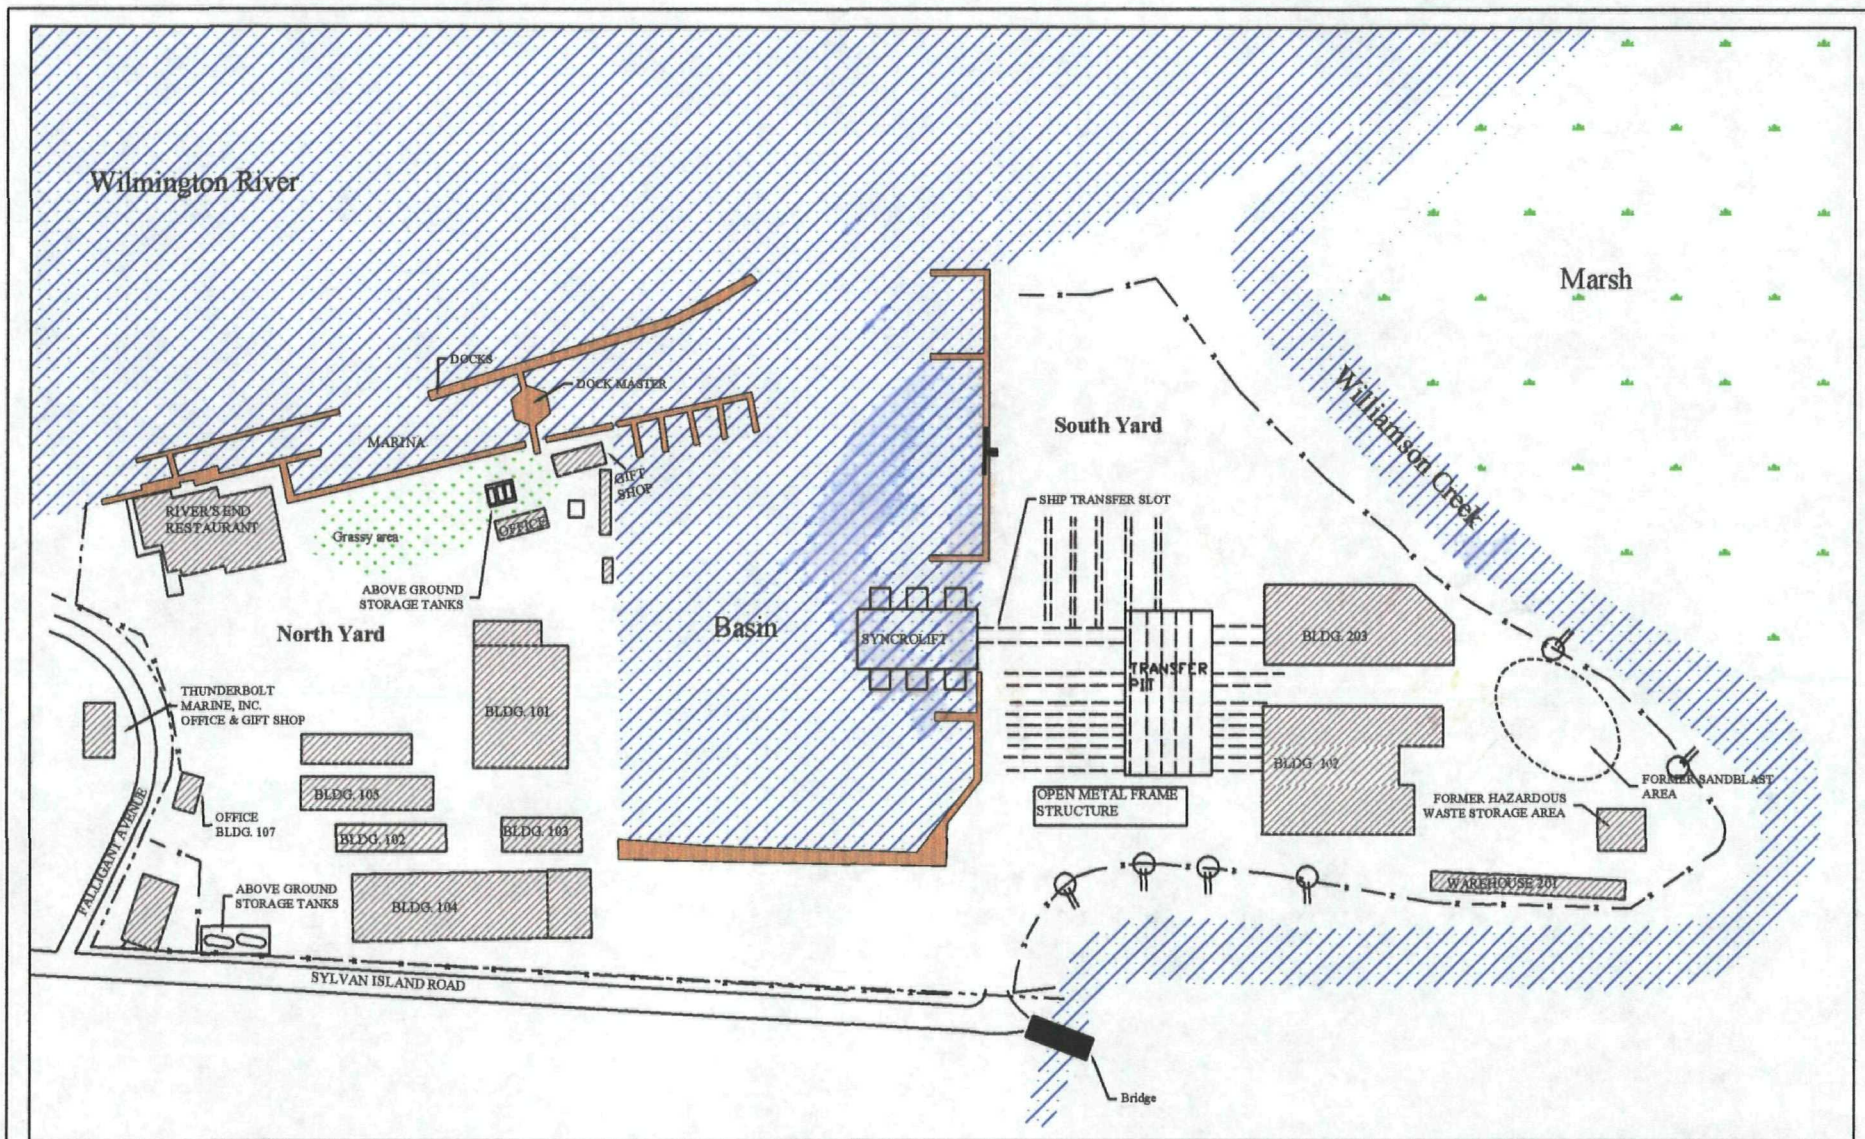
- Building 101 - Storage and small component fabrications
- Building 102 - Warehouse, lockers, machine repair
- Building 103 - Warehouse, offices, welding equipment maintenance
- Building 104 - Fabrication building
- Building 105 - Descaling and primer paint application (for a brief period until applications were moved to another building at an unspecified time)
- Building 107 - Human resources
- Aboveground fuel storage (no building number)
- Thunderbolt Marine, Inc.
- West storage area (an open lot used for parking vehicles)
- Building 201 - Warehouse storage
- Building 202 - Module building
- Building 203 - Outfitting building
- Sandblast area
- Hazardous waste storage area
- Subassembly platens 1 through 6
- Subassembly platens 1A, 1B, 2A, and 2B
- Pier No. 1
- Pier No. 2
- Basin

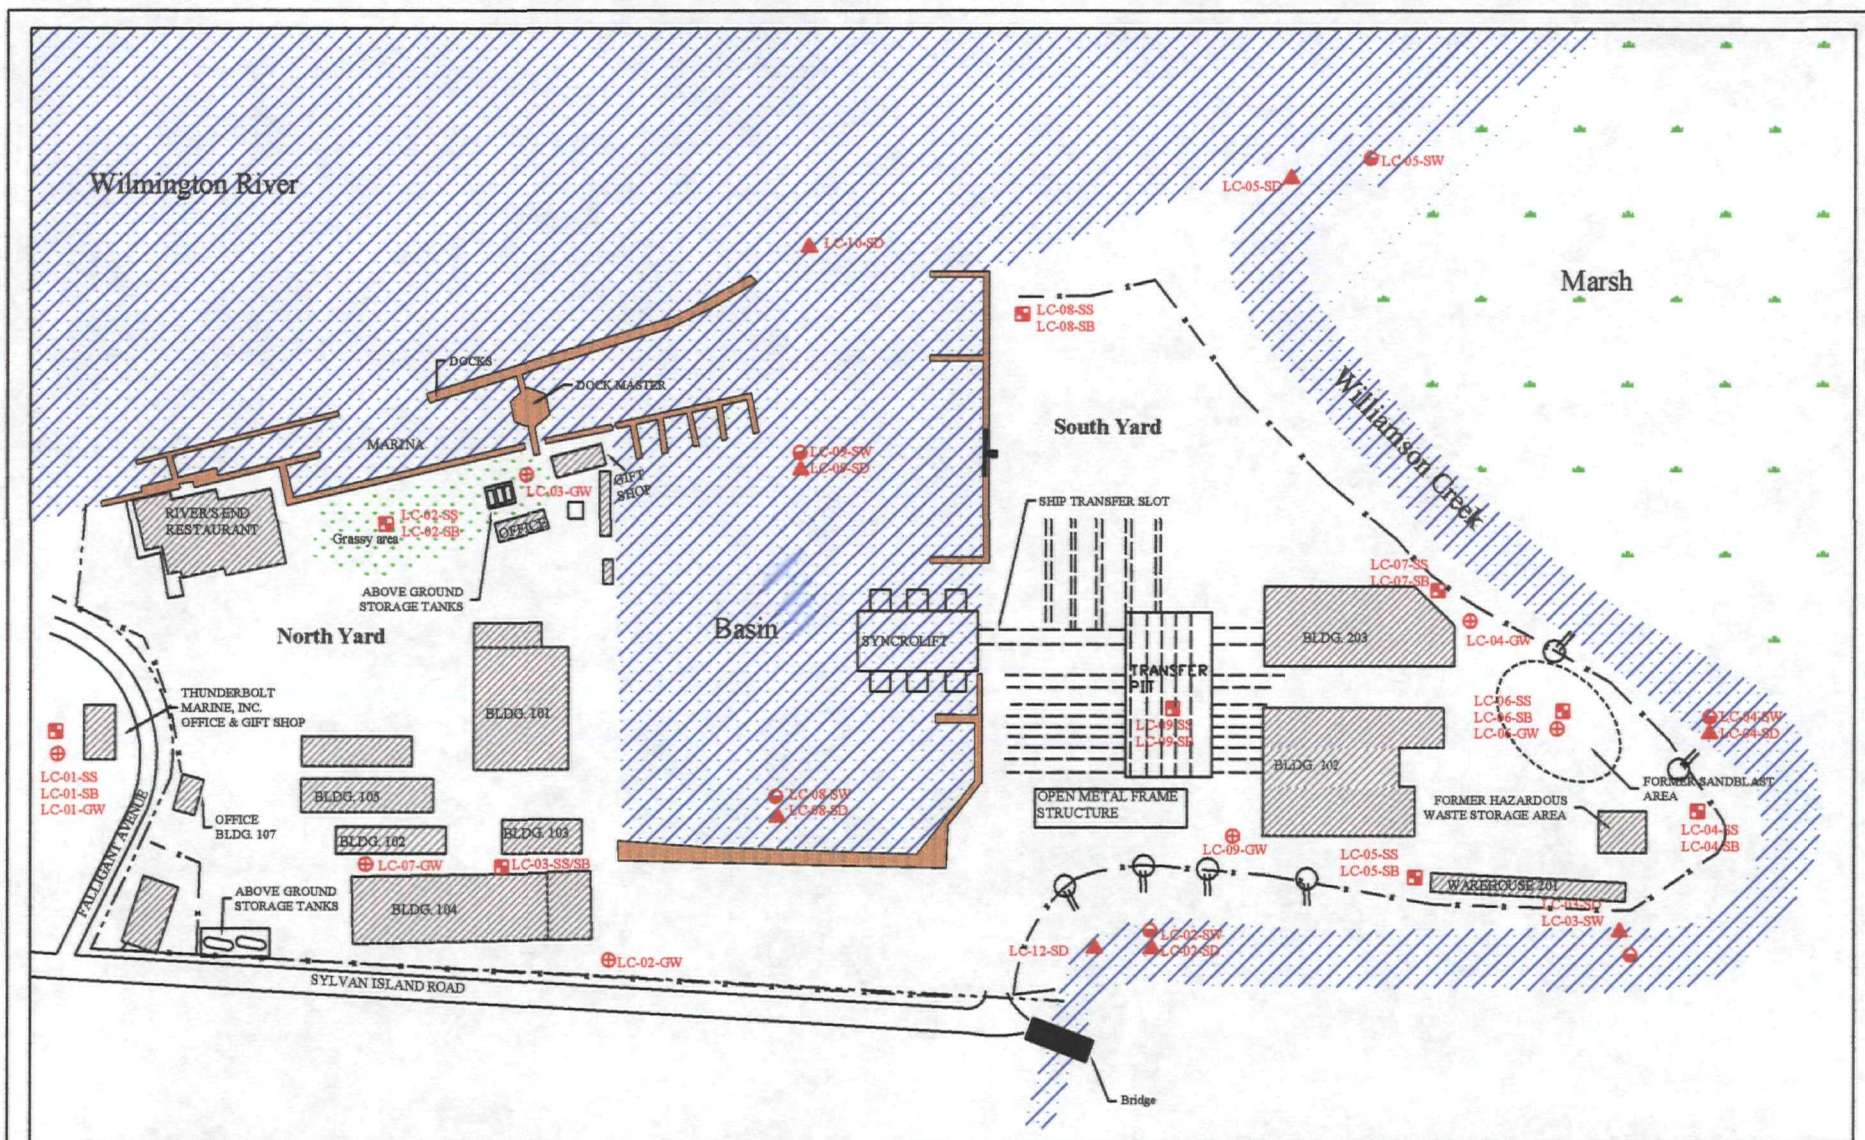
START personnel collected surface soil, subsurface soil, groundwater, and sediment samples during the ESI field sampling event. Sampling locations are shown on Figure 3 and summarized in Tables 1 through 3. START personnel collected the surface soil samples from 0 to 6 inches bls. Subsurface soil samples were collected from between 2 to 3 feet bls (Refs. 12; 36). All sampling was conducted in accordance with EPA Region 4 Science and Ecosystems Support Division's (SESD) *Environmental Investigations Standard Operating Procedures and Quality Assurance Manual* (EISOPQAM, 1996).

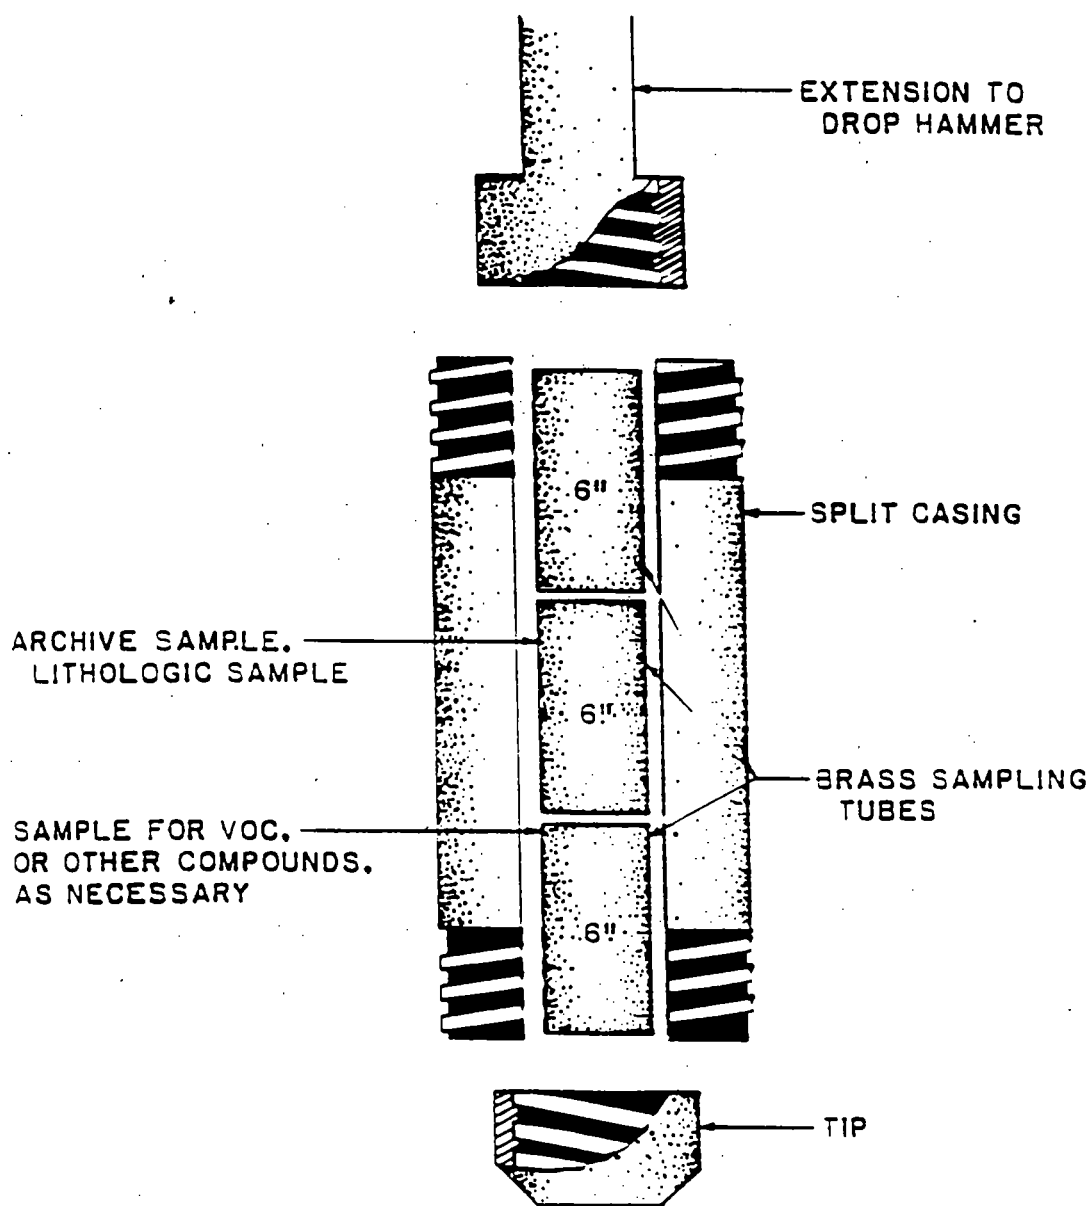
FIGURE 1-2  
DETAILS OF SPLIT-SPOON  
DRIVE SAMPLER

Upon removal from the borehole, the sampler is split longitudinally. If the sampled interval is designated for chemical analysis, the first six-inch cylinder for volatile organic compound (VOC) analysis is separated from the core by the insertion of metal blades between the brass cylinders. The sample cylinder, with soil intact, is immediately lifted from the core and the ends of the cylinder are sealed with teflon sheeting and plastic end caps. The end caps are sealed to the brass tube with duct tape. A sample label is then attached to the brass tube, with the date collected, sample and boring number, and depth recorded on the label. The samples are then placed in sealed plastic bags, and placed inside a cooler containing ice.

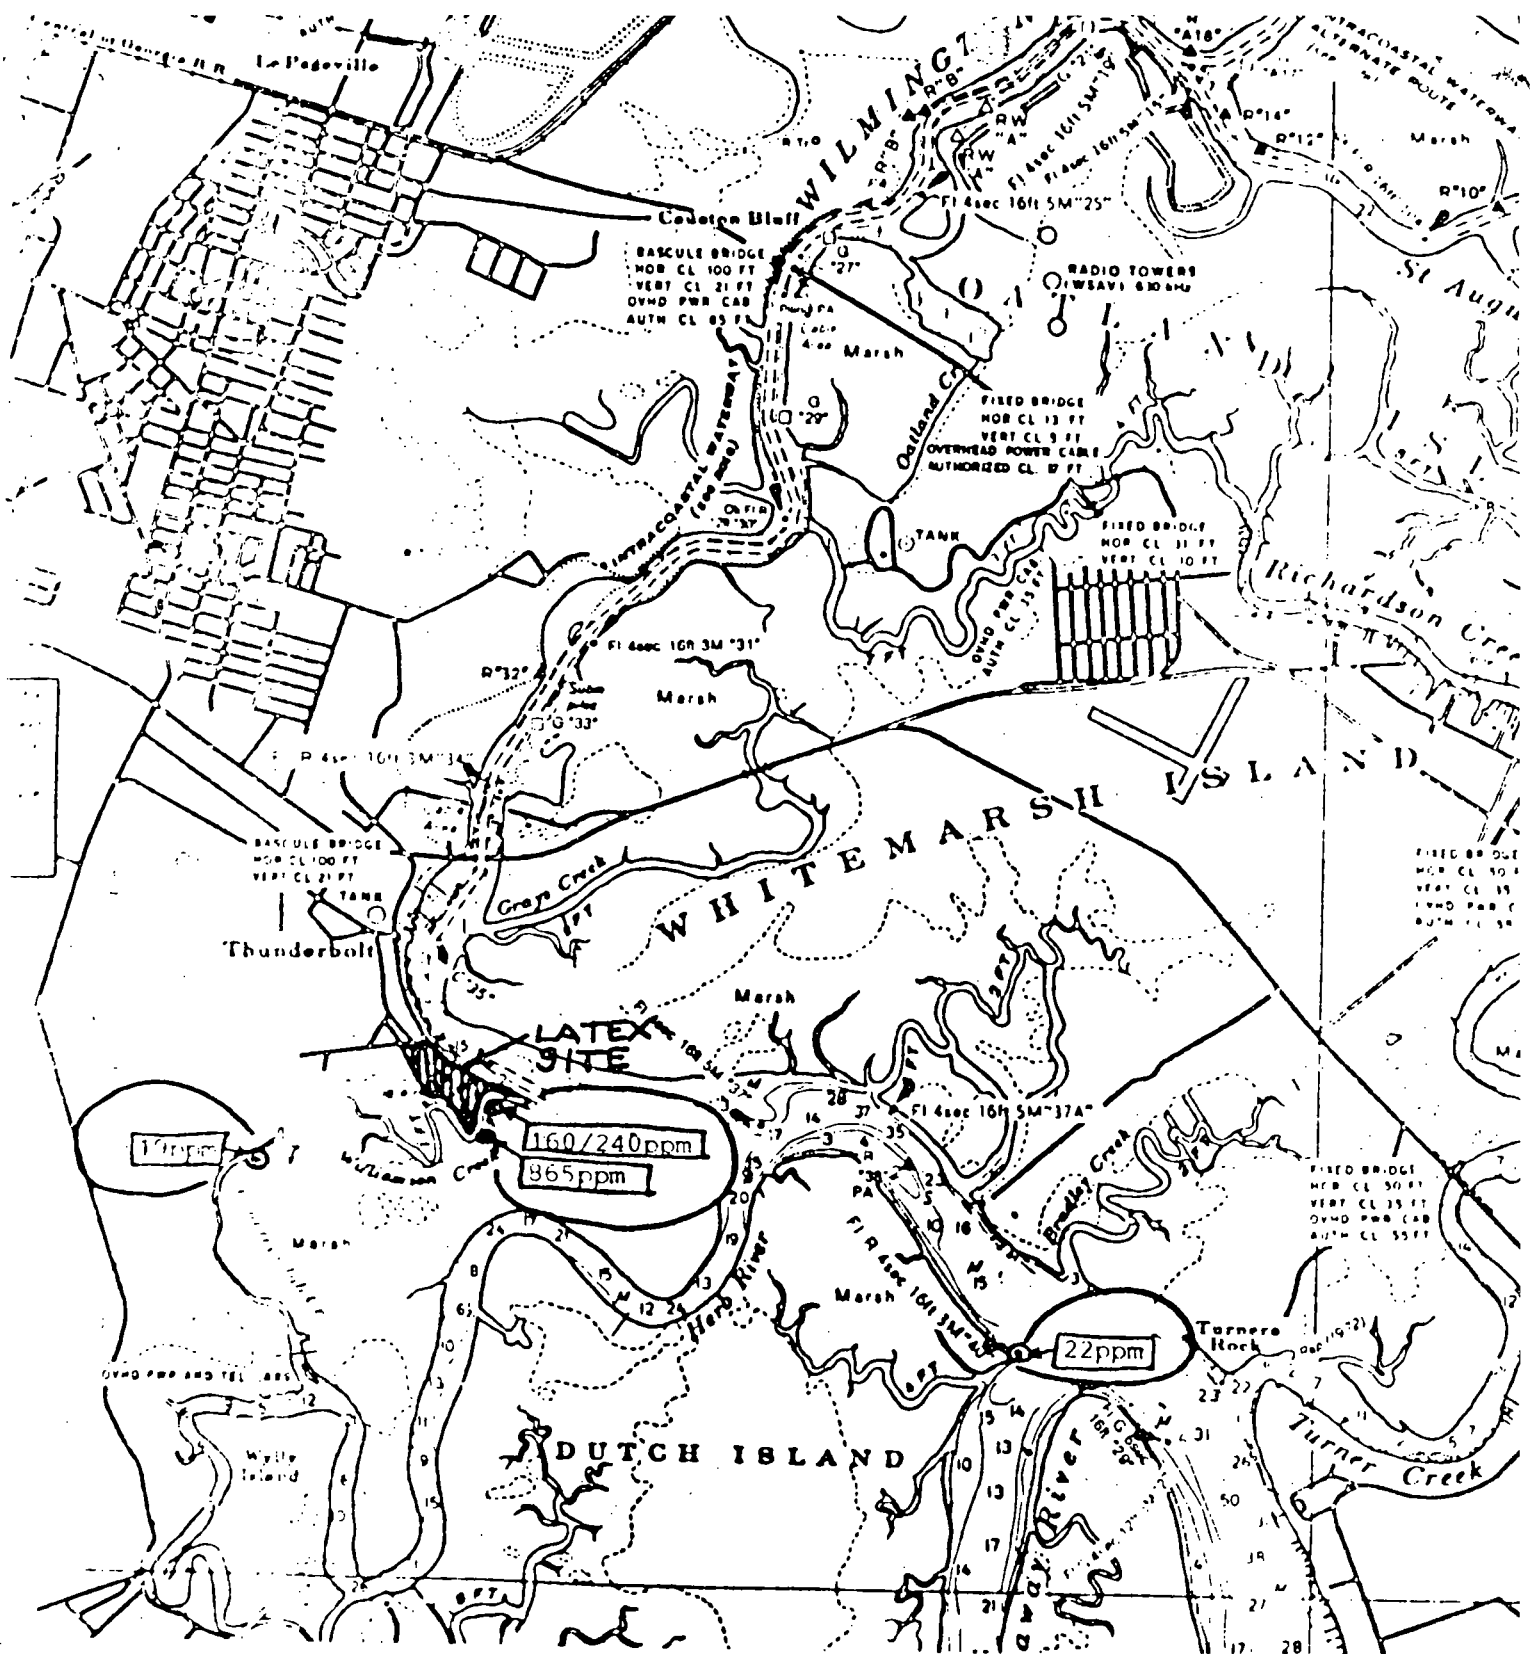
LEAD CONCENTRATION IN SEDIMENT (parts per million)  
Core samples taken from four locations

In summary, we found the heavy metal content of the sediment in Williamson Creek to contain lead as high as 865 PPM, copper as high as 640 PPM and zinc as high as 2600 PPM. Outside of the Latex impact area, the levels of lead, copper and zinc were 19, 6.6 and 35 PPM respectively. The lead level in the Savannah River sediment, considered by many to be polluted, as compared to the Wilmington River, was only 28 PPM adjacent to River Street.

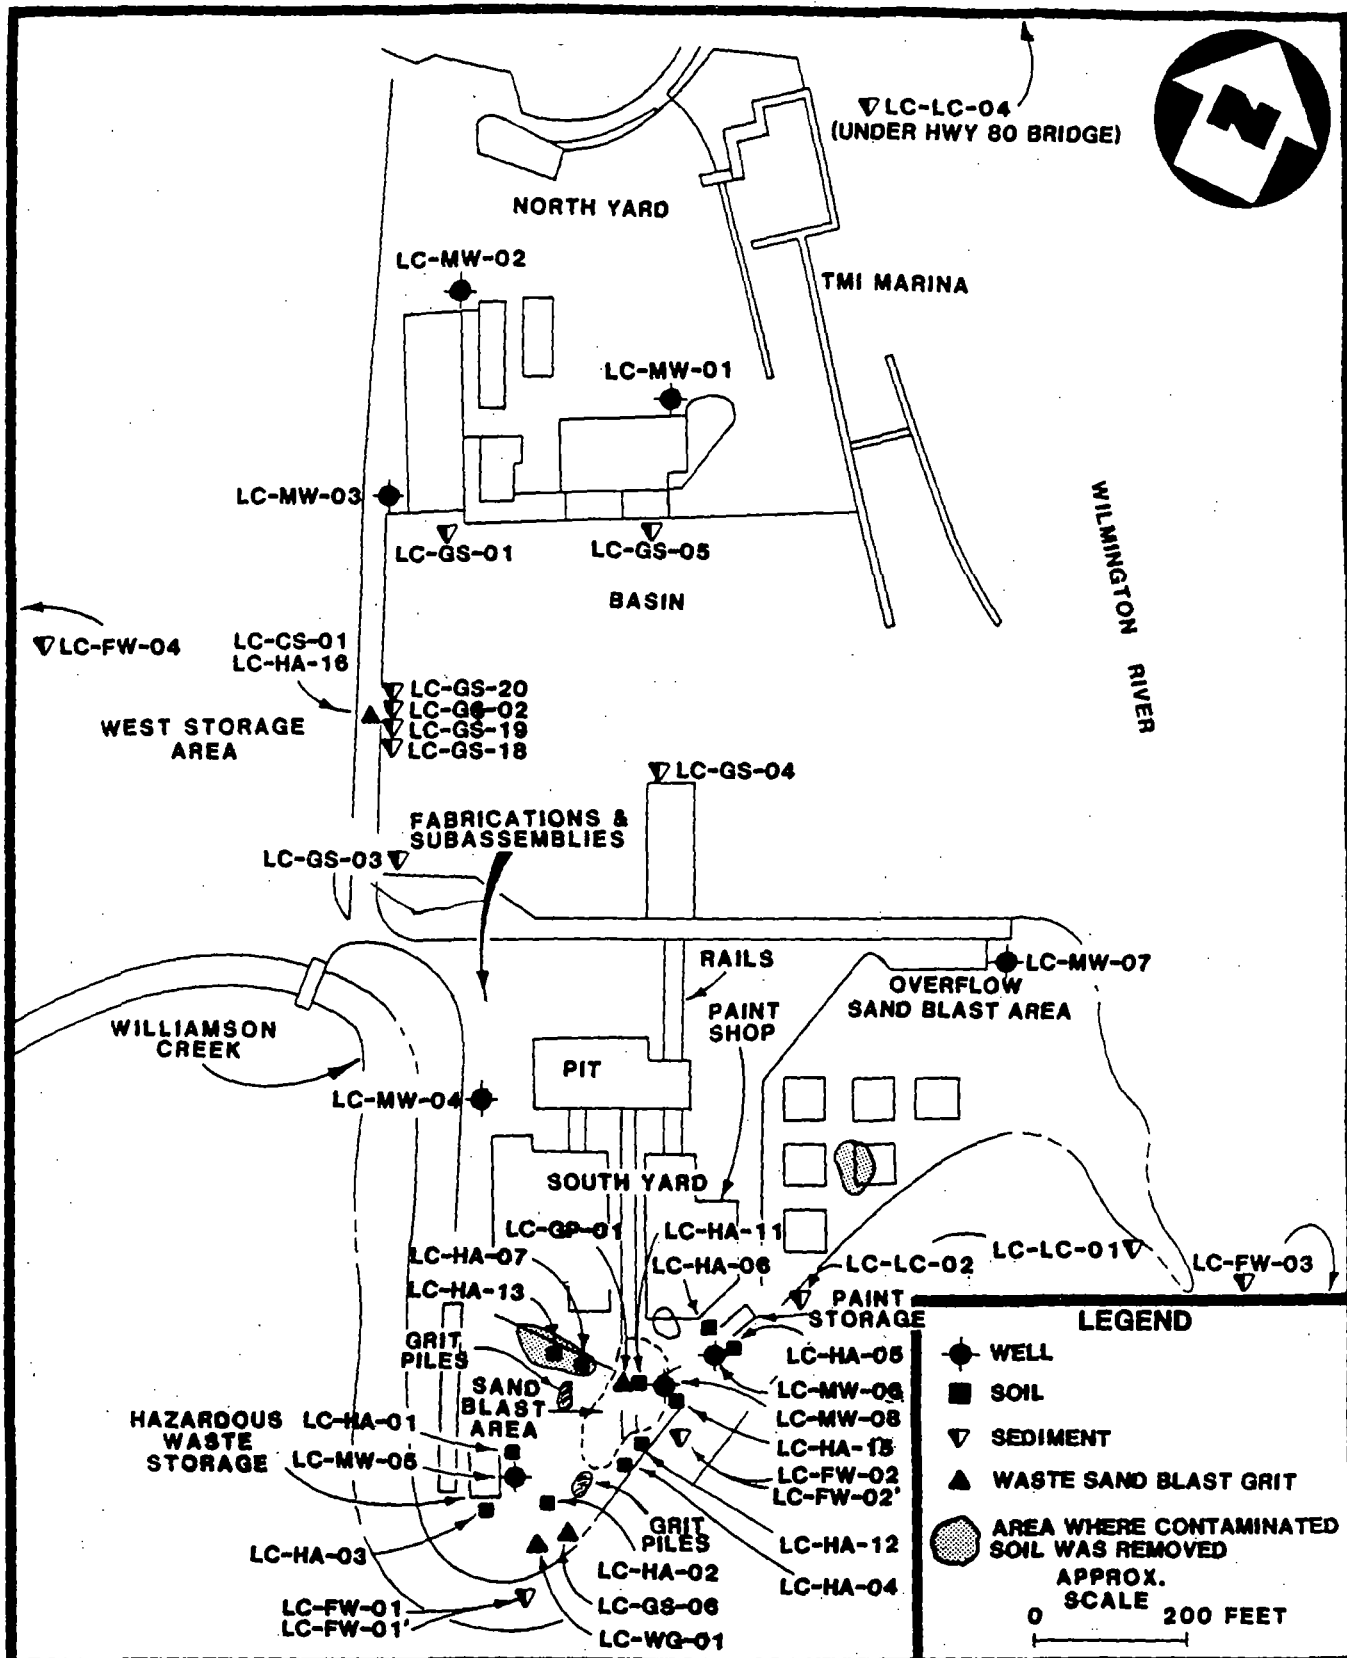
**SAMPLE LOCATIONS FROM PREVIOUS STUDIES  
LATEX CONSTRUCTION  
THUNDERBOLT, CHATHAM COUNTY, GEORGIA**

In 1983, a group of citizens known as "Friends of the Wilmington River" accused Latex of discharging heavy metals into Williamson Creek. Sediment samples (FW-1, FW-1', FW-2, FW-2'), taken by the citizens group near outfall pipes from the Latex facility, contained elevated concentrations of copper, lead, and zinc (Figure 3, Table 1) (Refs. 6, 7). Based on their samples, the citizens group attempted to block the approval of a dredging permit needed for the construction of a side-launch facility. In response to this, Latex Construction commissioned an independent study of sediments in the area to be dredged. The study concluded that metal concentrations in the sediments were within the normal ranges for the Savannah River (Table 1) (Refs. 8, 9). However, the background sample does not adequately represent background conditions because the sample was collected below the Highway

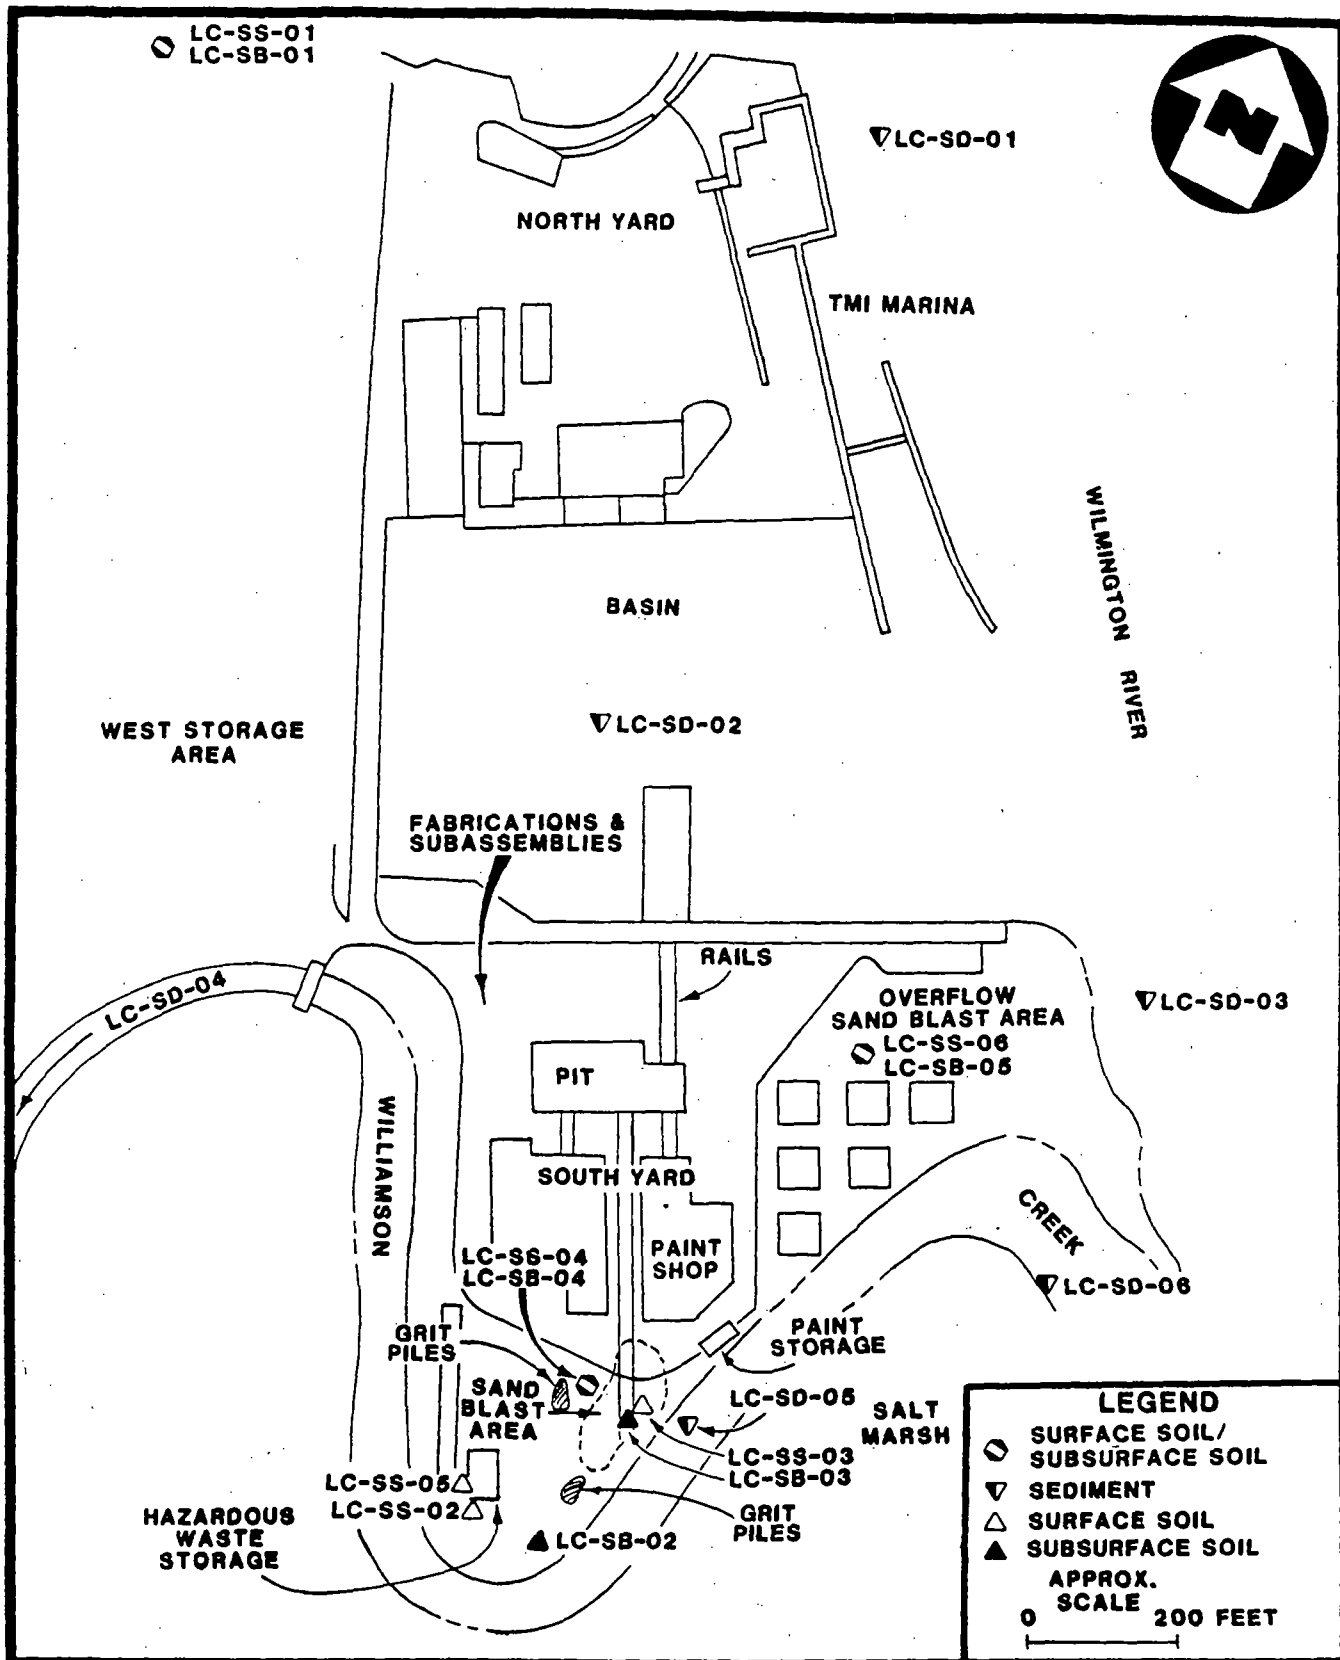
**SAMPLE LOCATION MAP  
LATEX CONSTRUCTION  
THUNDERBOLT, CHATHAM COUNTY, GEORGIA**

LC - Latex Construction  
SS - Surface Soil  
SB - Subsurface Soil  
SD - Sediment
